Test Report

Report Number FP231207050401

Sample Description LED

Model Specification RF-A3H10-W -E

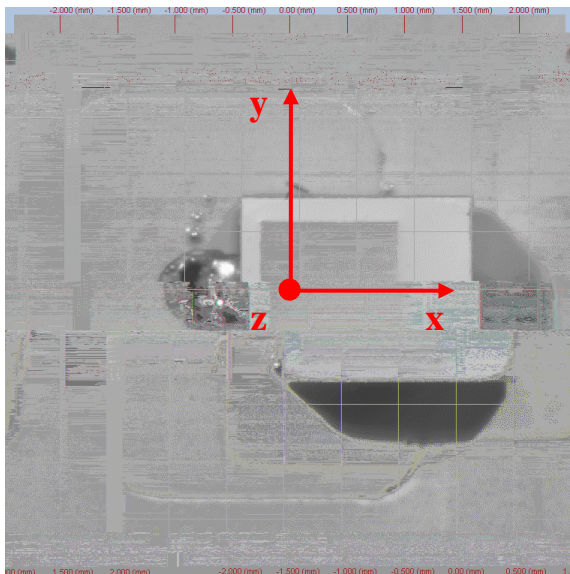
3 $I=0^\circ, A=0^\circ$
